## CORRECTION OF SERVICE MANUAL

Date: Dec.24,2004 No.: SCH04020 (1/3)

**Please correct your service manual**

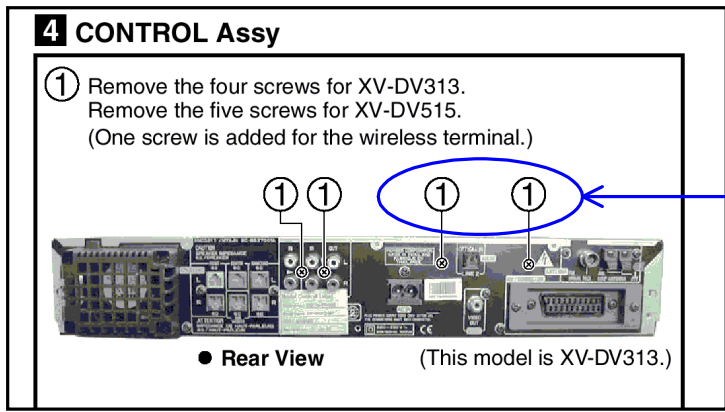
Refer to RRV2772 page:118

Make sure to tighten the 2 screws when assemble the unit because the DSP assy on the CONTROL assy gets the GND from the rear panel.
