CORRECTION OF SERVICE MANUAL

No.: SCH04020-A 1/6

Please correct your service manual

Please discard the previous Service Information SCH04020 dated Dec.24,2004.

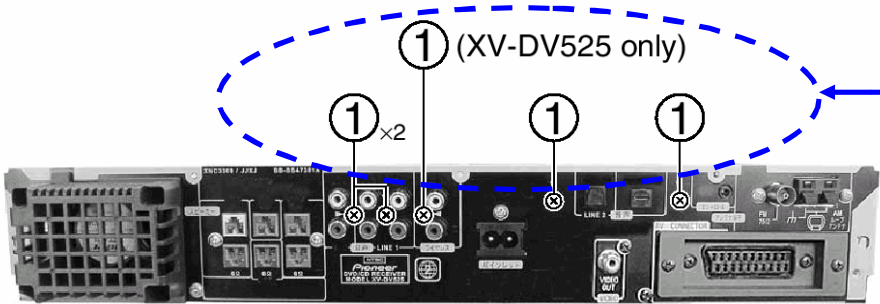
Refer to RRV2906 page:103

Make sure to tighten these screws when assemble the unit because the DSP assy on the CONTROL assy gets the GND from the rear panel.

3 CONTROL Assy

① Remove the five screws. (for XV-DV525)
Remove the four screws. (for XV-DV424 and XV-DV323)

● Rear view

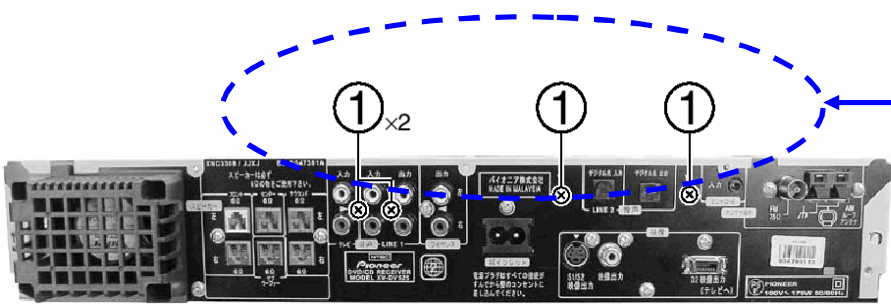
Refer to RRV2946 page:102

3 CONTROL Assy

① Remove the four screws.

● Rear view

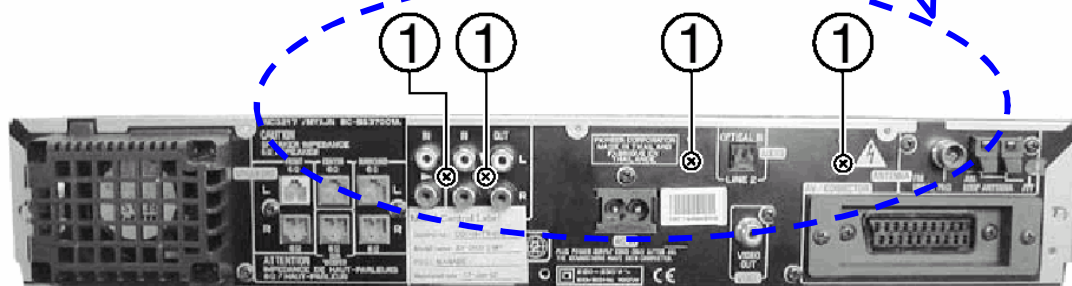
Refer to RRV2772 page 118.

Make sure to tighten these screws when assemble the unit because the DSP assy on the CONTROL assy gets the GND from the rear panel.

4 CONTROL Assy

- 1 Remove the four screws for XV-DV313.
Remove the five screws for XV-DV515.
(One screw is added for the wireless terminal.)

● Rear View

(This model is XV-DV313.)

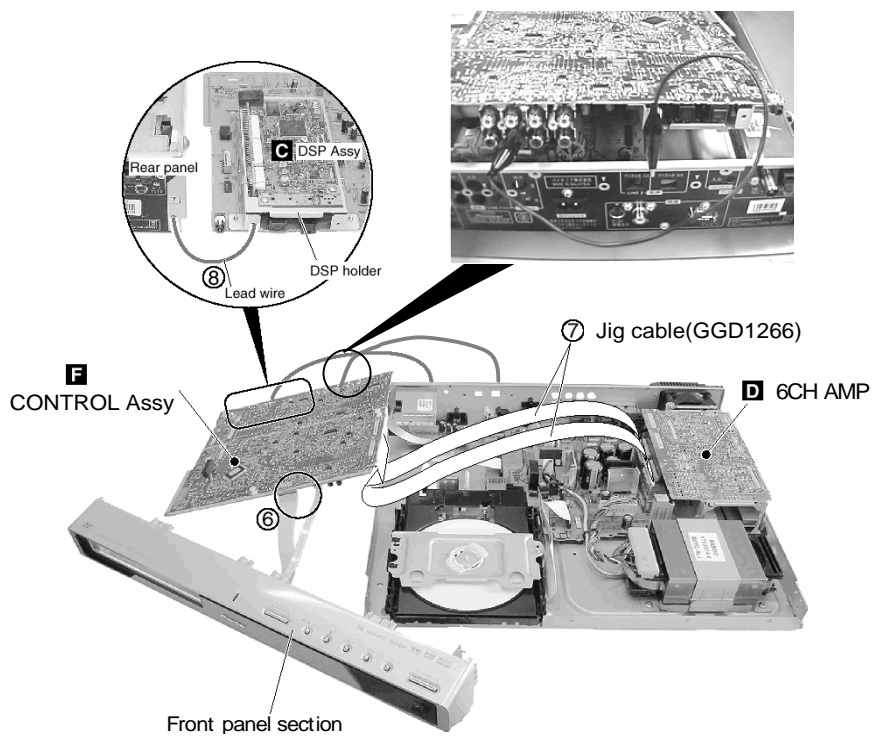
<4>Please substitute this page for RRV2906 page 104 and RRV2946 page 103.

- 6) Reattach the front panel section.
- 7) Connect the jig cable.
- 8) Connect the following parts to the chassis
 - #DSP Holder
 - #Audio Terminal GND

Caution;

If the Power is turned on when the DSP Holder (DSP GND) and the Audio Terminal GND are not connected to the rear panel (chassis), the protection, "PRTCT ERR" works blinking the TIMER LED on the FL display and the parts below may be destroyed at the DSP ASSY.

IC8702 : TC74VHCT244AFT

IC8401 : AK4529VQ

R8415 : 4.7O

If the above parts are destroyed, the audio signal can not be out.

Release the protection detection entering the "Service Test Mode".

See the "PROTECTION CIRCUIT" tips to enter it.

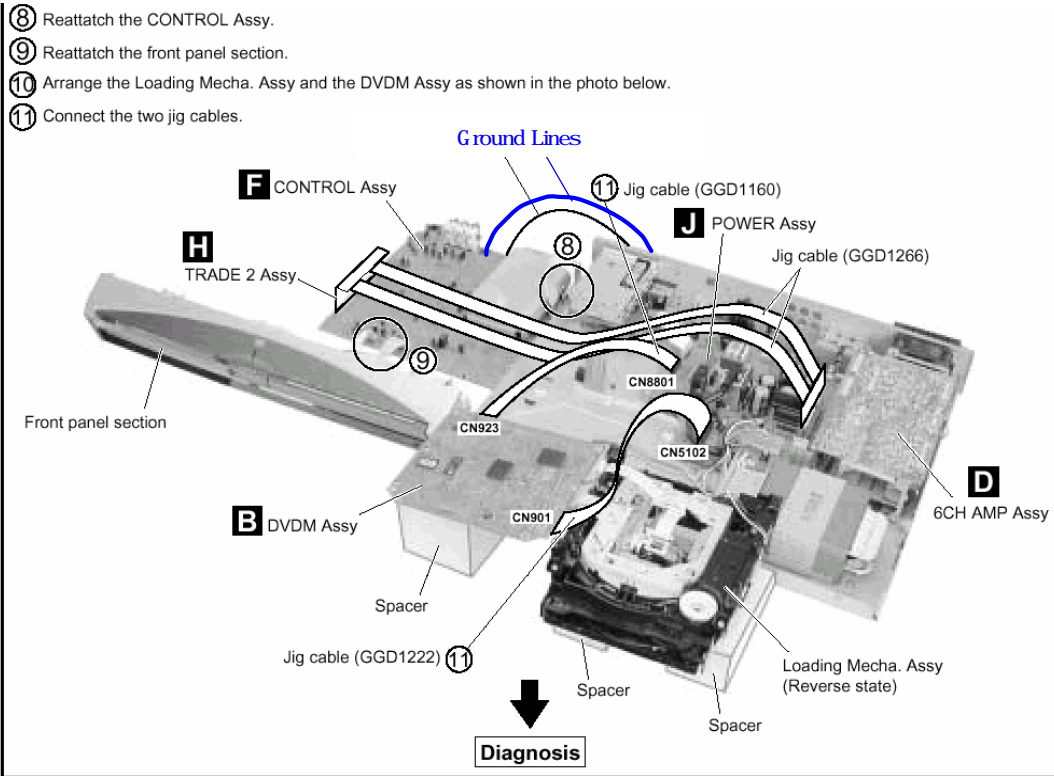
Please refer to RRV2772 page 120.

<5>Please add the following contents and lines.
